# Inspection Report

**Property Address:**  
388 Rasberry Lane  
Asheville, NC

## HomeBuyers Inspection HBI

<b>Date:</b> 9/4/2006	<b>Time:</b> 3:40 PM	<b>Report ID:</b> Sample one
<b>Property:</b> 388 Rasberry Lane Asheville, NC	<b>Customer:</b> Joan Bridgett	<b>Real Estate Professional:</b>

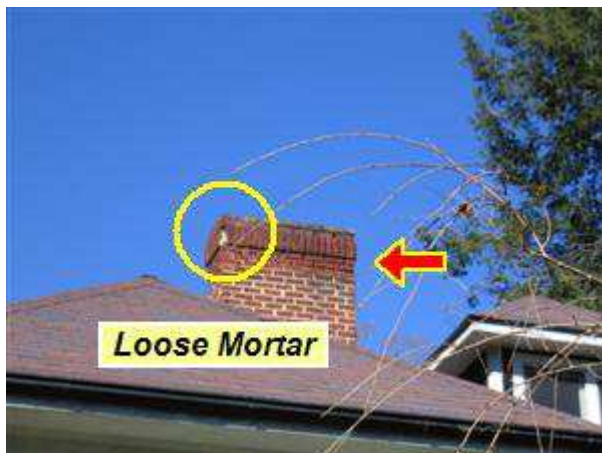
1.2 Picture 1

1.2 The brick chimney has loose mortar and missing bricks. Further deterioration may occur if not repaired. A qualified contractor should inspect and repair as needed.

The brick chimney has loose mortar and missing bricks. Further deterioration may occur if not repaired. A qualified contractor should inspect and repair as needed.

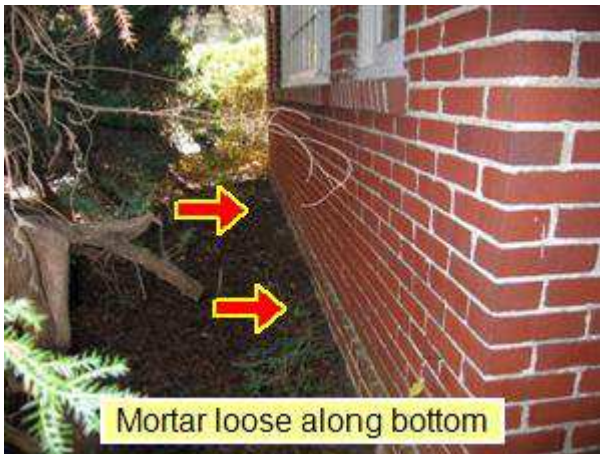
2.0 Picture 1

2.0 The Brick siding at the left side (facing front) is loose, and missing mortar. Further deterioration can occur if not corrected. A qualified contractor should inspect and repair as needed.

The Brick siding at the left side (facing front) is loose, and missing mortar. Further deterioration can occur if not corrected. A qualified contractor should inspect and repair as needed.

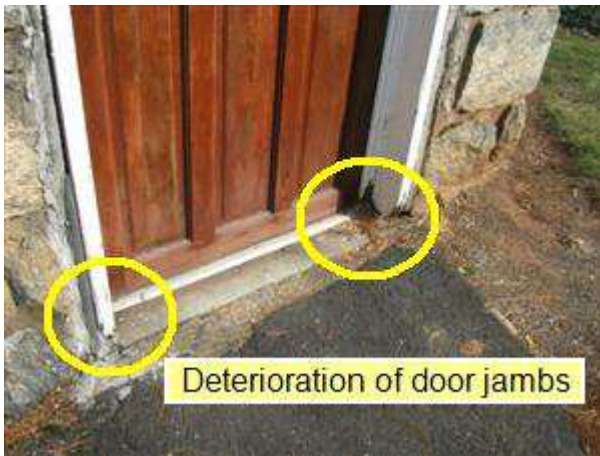
2.1 Picture 1 Rear entry door

2.1 The main entry door at rear of home is deteriorated at bottom of jamb (s). Further deterioration may occur if not repaired. A qualified contractor should inspect and repair as needed.

The main entry door at rear of home is deteriorated at bottom of jamb (s). Further deterioration may occur if not repaired. A qualified contractor should inspect and repair as needed.

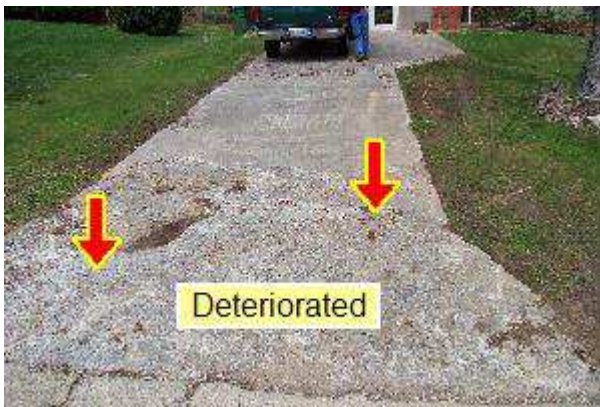
2.4 Picture 1

2.4 (1) The concrete drive at the front of home is deteriorated in areas. A general replacement is likely. A qualified contractor should inspect and repair as needed.

(1) The concrete drive at the front of home is deteriorated in areas. A general replacement is likely. A qualified contractor should inspect and repair as needed.

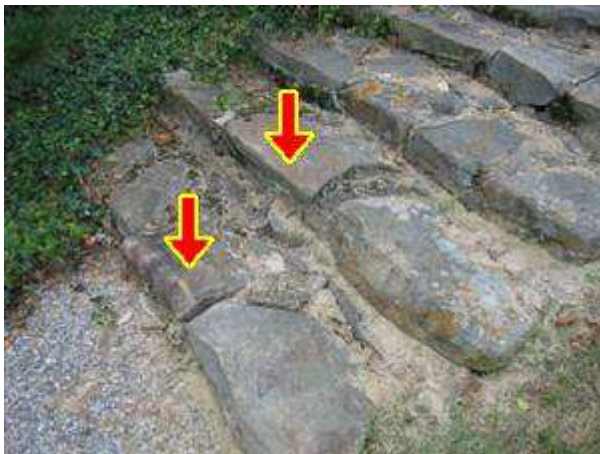
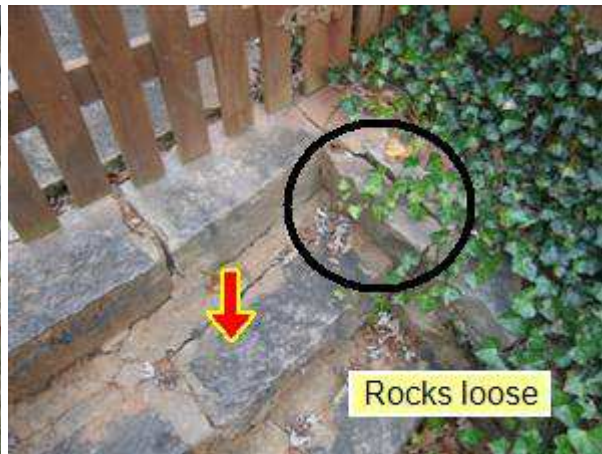
(2) The rock steps at the front of home and rear of home are loose in areas. Water can cause further deterioration if not repaired and sealed properly. A qualified contractor should inspect and repair as needed.

2.4 Picture 2 Front Steps

2.4 Picture 3 Rear steps

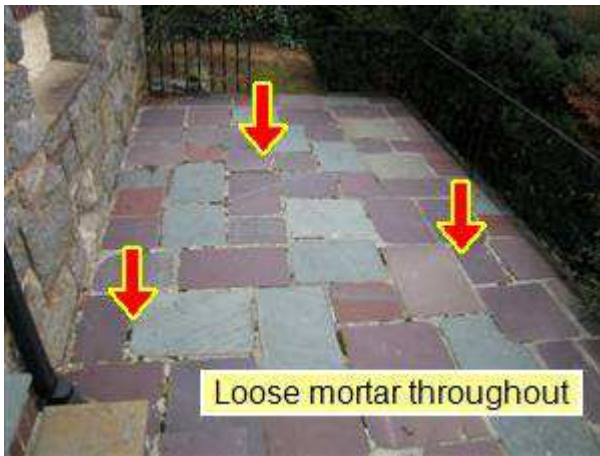
2.4 Picture 4

(3) The slate floor on the patio at the left side (facing front) has deteriorated mortar or grout, and is loose and uneven in areas. A general replacement is likely. A qualified contractor should inspect and repair as needed.

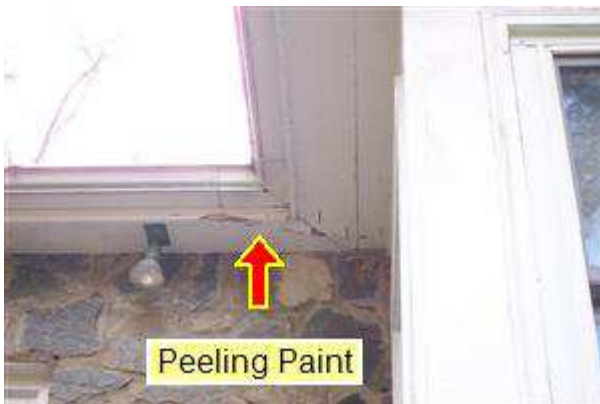
2.5 Picture 1

2.5 The soffit panel at eave on the front of home weathered and beginning to deteriorate. Further deterioration may occur if not repaired.

The soffit panel at eave on the front of home weathered and beginning to deteriorate. Further deterioration may occur

A qualified contractor should inspect and repair as needed.

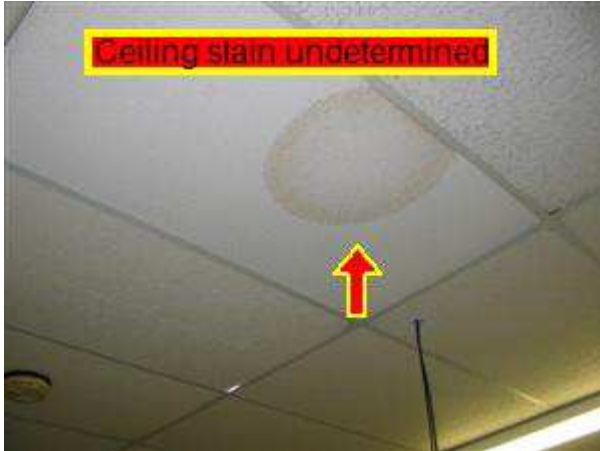
4.0 The Ceiling Tile on the ceiling reveals a water stain indicating a leak did or still exists at the Dining Room. Repairs are needed. A qualified contractor should inspect and repair as needed.

4.0 Picture 1 DR Ceiling

- ☒ The Ceiling Tile on the ceiling reveals a water stain indicating a leak did or still exists at the Dining Room. Repairs are needed. A qualified contractor should inspect and repair as needed.

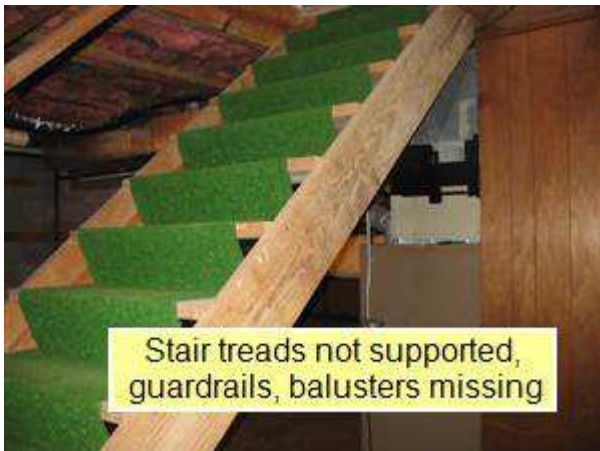
4.3 The hand/guard rail for the stairs to basement are missing balusters. Spacing more than 4 inches apart could allow an adult, child or pet to fall through. Treads are not supported properly. A qualified contractor should repair or replace as needed.

4.3 Picture 1 basement stairs

- ☒ The hand/guard rail for the stairs to basement are missing balusters. Spacing more than 4 inches apart could allow an adult, child or pet to fall through. Treads are not supported properly. A qualified contractor should repair or replace as needed.

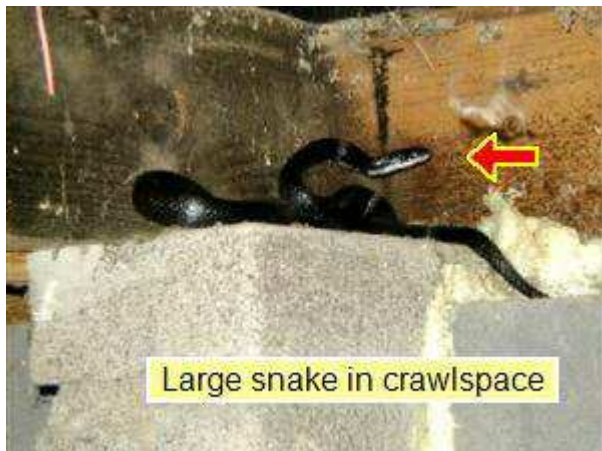
5.0 There is a large snake in crawlspace. Recommend feeding it regularly.

5.0 Picture 1 Black snake

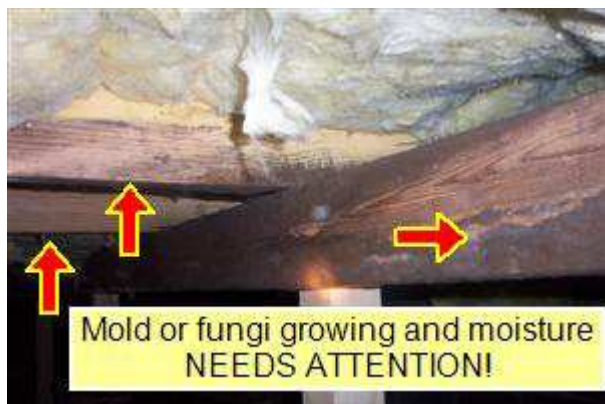
5.3 Picture 1

5.3 Signs of fungi growth is present on the floor system in crawlspace in several areas. We did not inspect, test or determine if this growth is or

is not a health hazard. The underlying cause is moisture. I recommend you contact a mold inspector or expert for investigation or correction if needed.

☒ Signs of fungi growth is present on the floor system in crawlspace in several areas. We did not inspect, test or determine if this growth is or is not a health hazard. The underlying cause is moisture. I recommend you contact a mold inspector or expert for investigation or correction if needed.

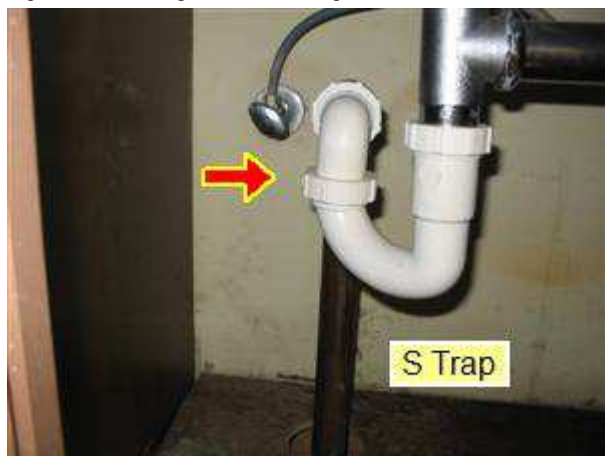
**6.0** The waste line has a S-trap, and should be changed to a P-trap and "Auto-vent" at the Kitchen sink. This is not considered up to today's standard. A qualified licensed plumber should repair or correct as needed.

6.0 Picture 1 Under Kitchen sink

The waste line has a S-trap, and should be changed to a P-trap and "Auto-vent" at the Kitchen sink. This is not considered up to today's standard. A qualified licensed plumber should repair or correct as needed.

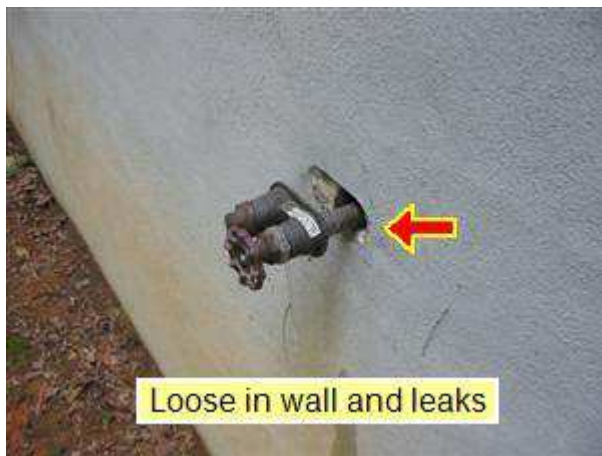
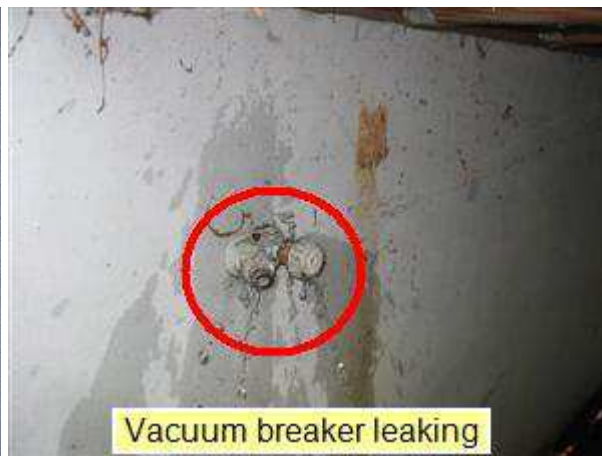
**6.1 (1)** The outside water faucets are loose, and needs securing to wall , leaks when turned on and leaks at vacuum breaker at the right side (facing front) and left side (facing front). Repairs are needed. A qualified licensed plumber should repair or correct as needed.

6.1 Picture 1 Right side facing front

6.1 Picture 2 Left side facing front

(1) The outside water faucets are loose, and needs securing to wall , leaks when turned on and leaks at vacuum breaker at the right side (facing front) and left side (facing front). Repairs are needed. A qualified licensed plumber should repair or correct as needed.

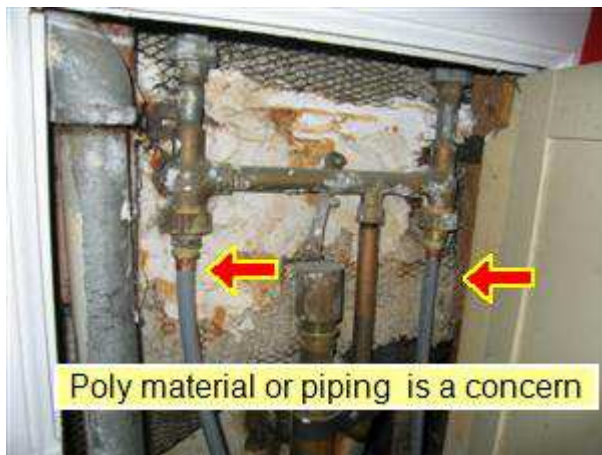
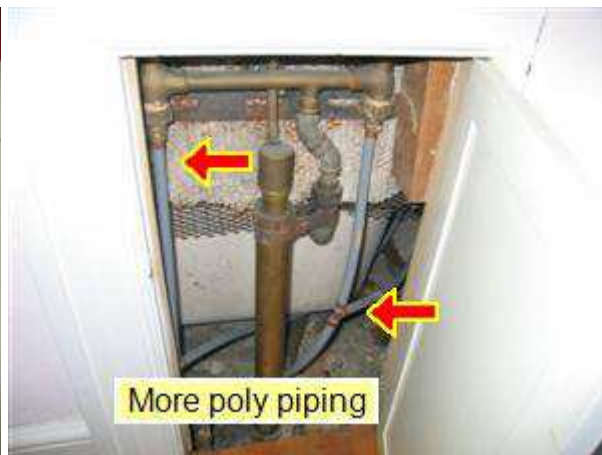
(2) Polybutylene plastic plumbing supply lines (PB) are installed in the subject house. Polybutylene has been used in this area for many years, but has had a higher than normal failure rate, and is no longer being widely used. Copper and Brass fittings used in later years have apparently reduced the failure rate. This subject house has copper fittings. For further details contact the Consumer Plumbing Recovery center at 1-800-392-7591 or the web at <http://www.pbpipeline.com>

6.1 Picture 3 Hall bath closet access

6.1 Picture 4 Master bath closet access

(2) Polybutylene plastic plumbing supply lines (PB) are installed in the subject house. Polybutylene has been used in this area for many years, but has had a higher than normal failure rate, and is no longer being widely used. Copper and Brass fittings used in later years have apparently reduced the failure rate. This subject house has copper fittings. For further details contact the Consumer Plumbing Recovery center at 1-800-392-7591 or the web at <http://www.pbpipe.com>

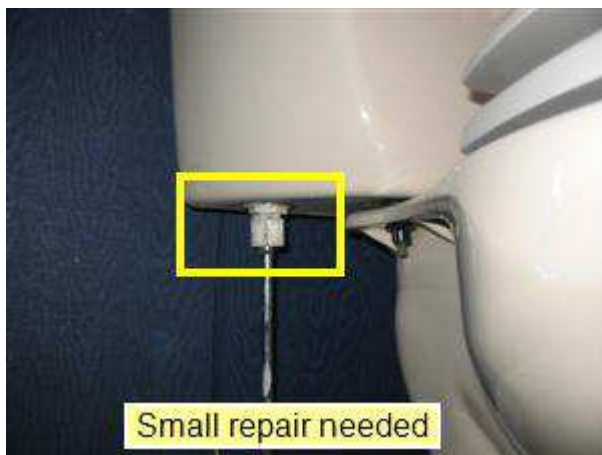
(3) The toilet supply valve for toilet is leaking at the hall bath. Repairs are needed. A qualified person should repair as necessary.

6.1 Picture 5 Hall toilet

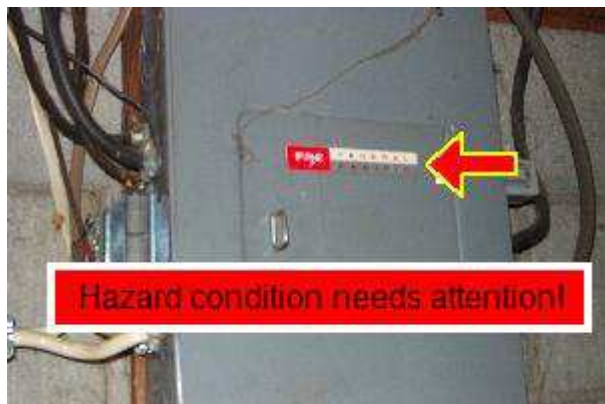
**7.2** You have a Federal Pacific panel which is legal, but there is a possibility that the circuit breakers may not trip when shorted possibly causing an electrical hazard. Opinions by licensed electricians on this panel varies between safe and unsafe. I recommend you consult a licensed electrician for an opinion and correct if necessary.

7.2 Picture 1 Federal Panel in basement

You have a Federal Pacific panel which is legal, but there is a possibility that the circuit breakers may not trip when shorted possibly causing an electrical hazard. Opinions by licensed electricians on this panel varies between safe and unsafe. I recommend you consult a licensed electrician for an opinion and correct if necessary.

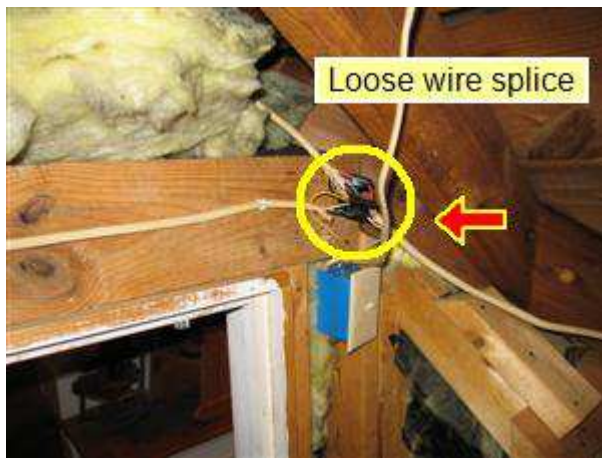
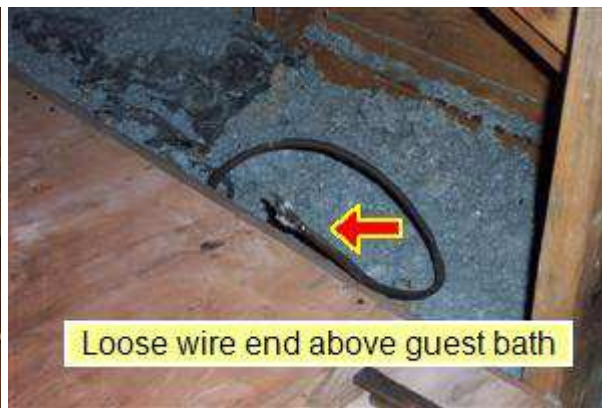
**7.3** One loose wire splice and One loose wire end need placing in boxes with cover-plates within "Five feet" of attic access and above the Guest bath in attic. This is a safety issue that needs to be corrected. I recommend a qualified licensed electrician correct.

7.3 Picture 1 near attic access

7.3 Picture 2 attic view

One loose wire splice and One loose wire end need placing in boxes with cover-plates within "Five feet" of attic access and above the Guest bath in attic. This is a safety issue that needs to be corrected. I recommend a qualified licensed electrician correct.

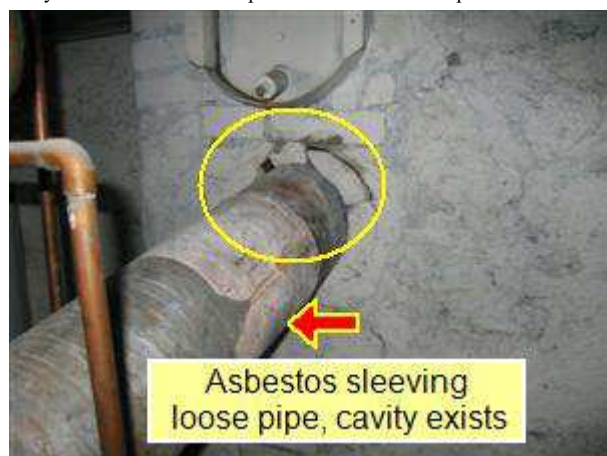
**8.5** The vent pipe for oil fired boiler needs mastic sealed around pipe where it enters chimney. Possible asbestos sleeving on vent pipe. This is a safety issue and should be repaired. I recommend a qualified licensed heat contractor inspect further and repair as needed.

8.5 Picture 1 vent pipe at basement

The vent pipe for oil fired boiler needs mastic sealed around pipe where it enters chimney. Possible asbestos sleeving on vent pipe. This is a safety issue and should be repaired. I recommend a qualified licensed heat contractor inspect further and repair as needed.

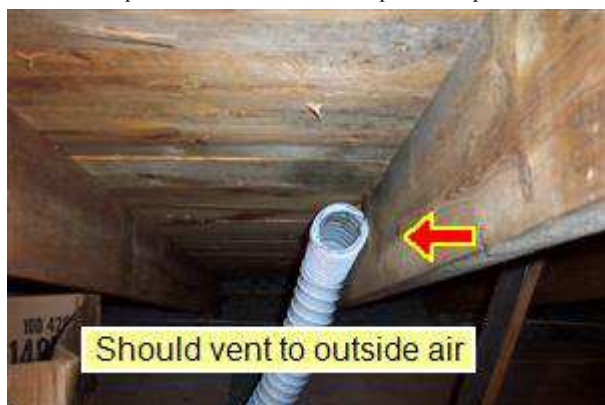
9.4 The Exhaust fan does not vent to outside at the guest bath. Vent pipes should terminate outside and not in the attic. Many homes have their vent pipe poised at the roof vent such as yours. It is up to you to determine whether or not this is a concern or needs further consideration from a general contractor. A qualified contractor should inspect and repair as needed.

9.4 Picture 1 Exhaust from bath fan

- ☒ The Exhaust fan does not vent to outside at the guest bath. Vent pipes should terminate outside and not in the attic. Many homes have their vent pipe poised at the roof vent such as yours. It is up to you to determine whether or not this is a concern or needs further consideration from a general contractor. A qualified contractor should inspect and repair as needed.
